**FINAL REPORT OF COMPREHENSIVE EVALUATION FOR  
ASBESTOS-CONTAINING MATERIALS SURVEY, PCB BALLAST, MERCURY  
VAPOR BULB, AND HEAVY METAL CONTAMINATED COATING,**

P-625, BUILDING 701 and 606, SUBSTATION 531, TRANSFORMER 662  
SIGONELLA - NAS II  
SICILY, ITALY

**MACTEC PROJECT NO. 40280-2-2008/\*\*/606**

February 25, 2003

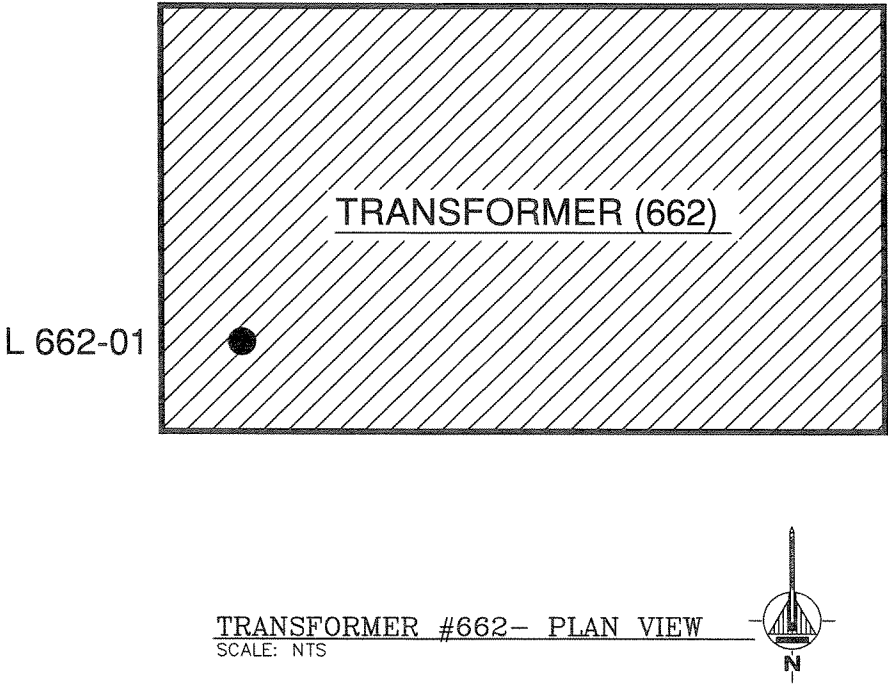
TRANSFORMER #662  
P-625, SIGONELLA - NAS II  
SICILY, ITALY

SAMPLE NO.	FLOOR	COLOR	COMPONENT	LOCATION / HA	SUBSTRATE	ORIENTATION	CONDITION	Pb%
L662-1	0	Beige	Unit	Exterior	M	Top	F-M	<0.01
COMMENTS	Typical of all exterior surfaces							
COMMENTS								
COMMENTS								
COMMENTS								
COMMENTS								
COMMENTS								
COMMENTS								
COMMENTS								
COMMENTS								
COMMENTS
